J.R. Simplot Company
Simplot Headquarters
1099 W. Front Street
Boise, Idaho 83702
P.O. Box 27
Boise, Idaho 83707

July 8, 2019

EXECUTIVE SUMMARY

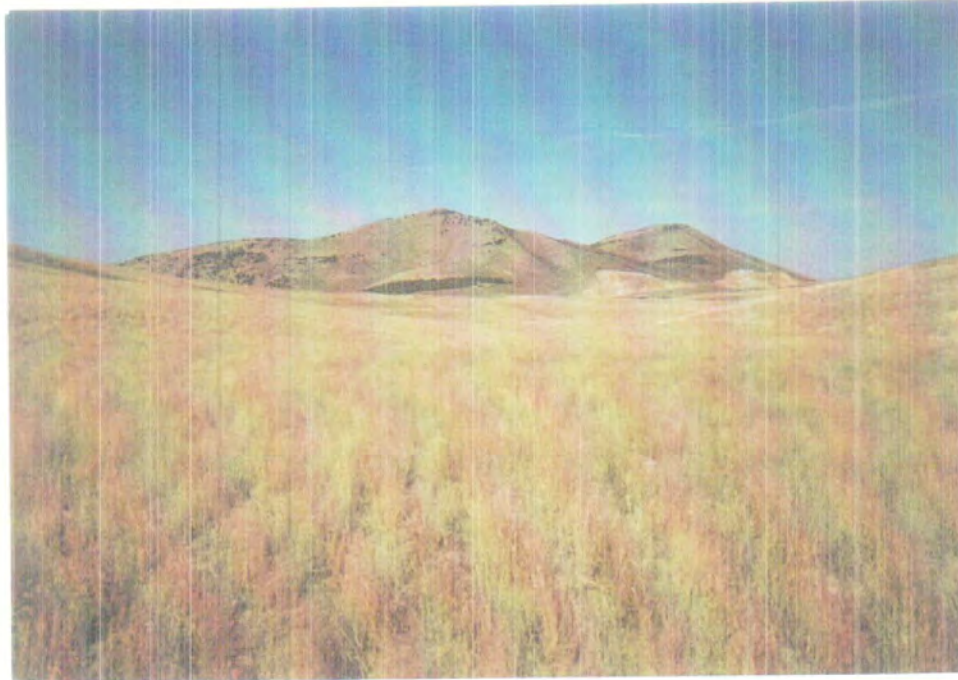
Figure 2. JG Pit Reclaimed One of the many examples of Gay Mine exemplary reclamation techniques. The pit has been backfilled to top of highwalls and regraded to create a closed basin effect. Topsoiling, ripping, tilling, seeding and fertilization have resulted in excellent diversified vegetative cover.

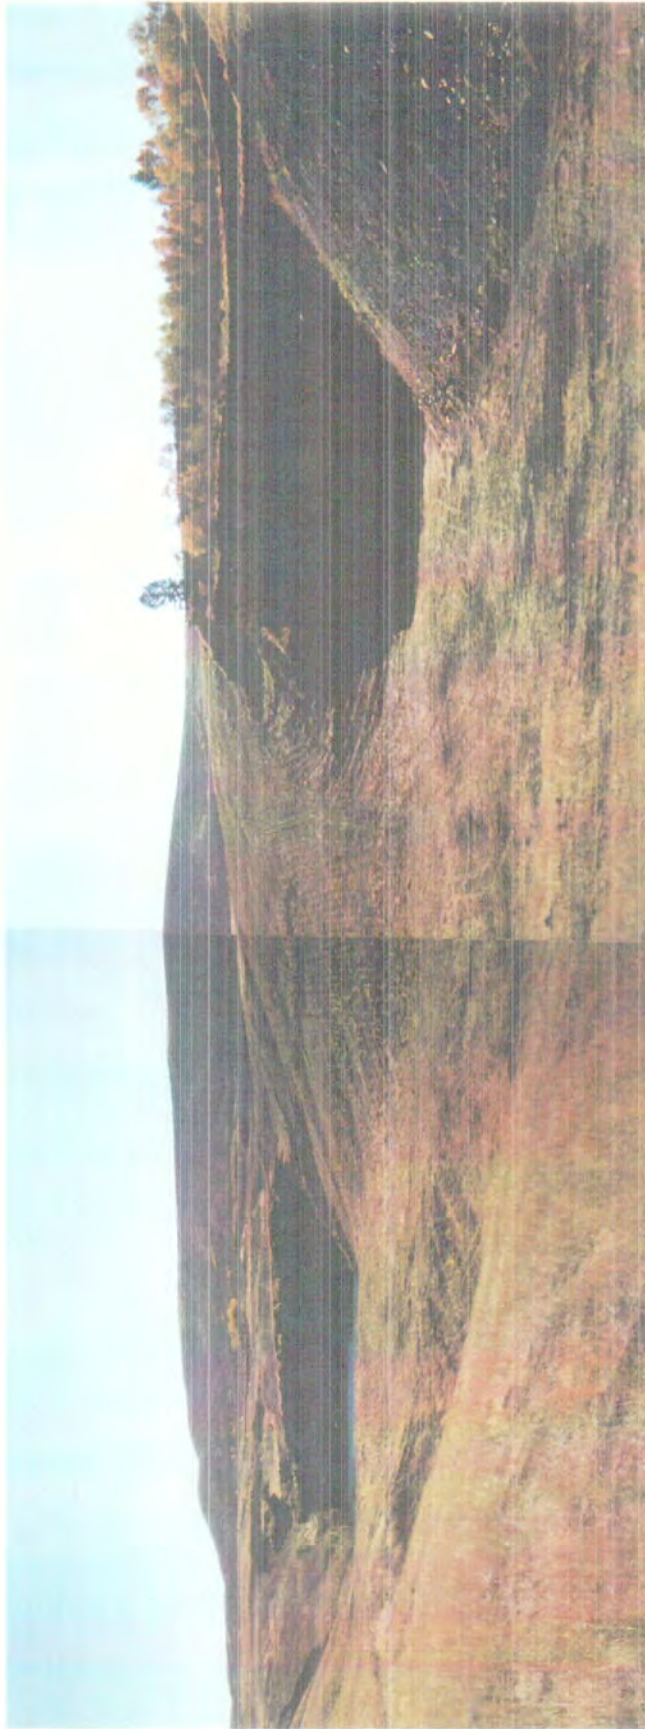
Figure 3 After reclamation, several problems remain or have been recently developed. On the north face of the lake (on left) several gullies have formed as a result of overflow coming off main haul road. The excavation on right needs to be stabilized by using material from both sides to regrade a shallow U-Shape that extends to half the height of the highwall. Highwalls with aspen stand can be allowed to slump naturally until angle of repose is achieved.

8. The A12 Lake lies at the bottom of an excavation approximately 225-240 feet deep. Three large gullies have formed on the north side as a result of continuous and unscheduled discharge of water from the upper storage ponds. This water drained abruptly, allowing lower catchment ponds to overload. As water was discharged from the ponds, the surplus was piped under the main haul road into a V-ditch and from there free-flowed into the old pit. The high volume and velocity of the discharge created deep cuts. These gullies have not been plugged, backfilled, regraded or reclaimed.

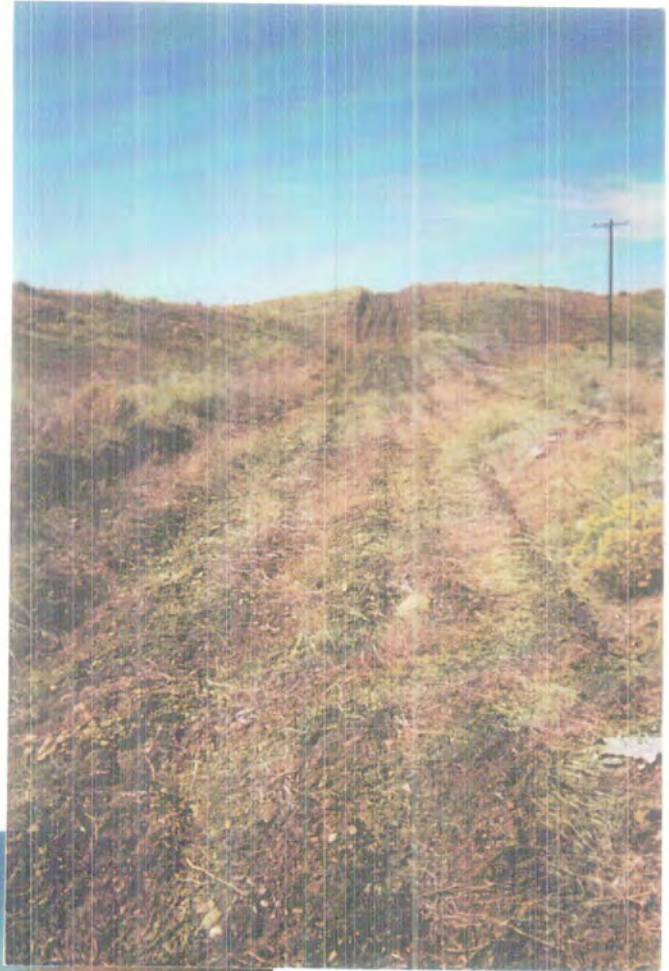
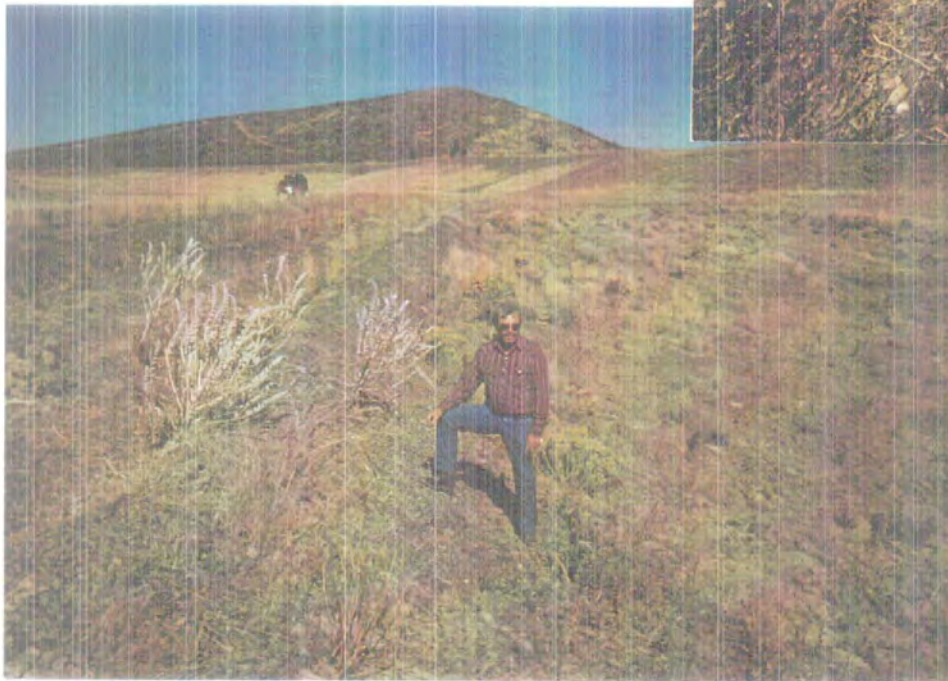
This and other haul roads have been vertically ripped resulting in water channeling and erosion. Sloped linear surfaces will require water bars, followed by harrowing and reseeding.

Figure 5 Weed Infestations Haul roads are the primary establishment corridors for noxious, invasive plant species. To the left is black henbane; to the right is musk thistle and Russian knapweed.

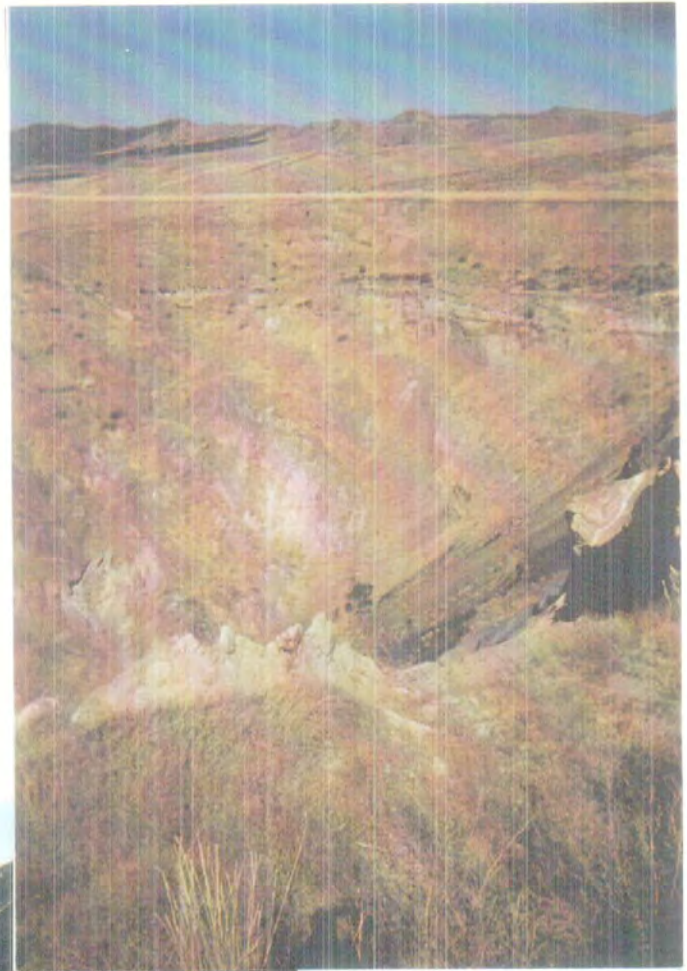
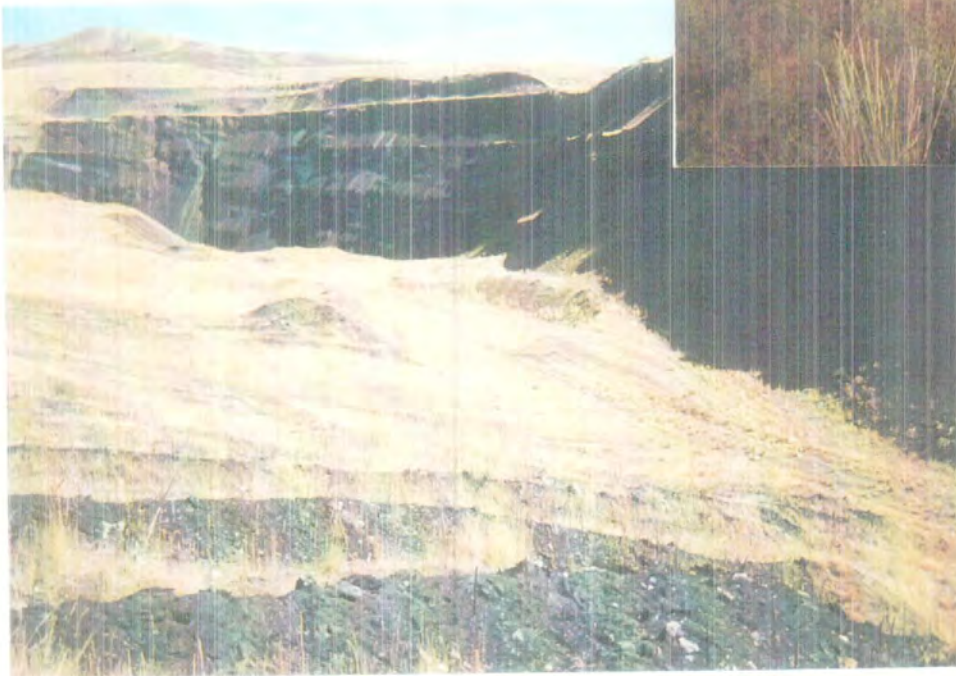
Figure 7 C9 Pit in North Limb

Located just to the right of the haul road, this pit was partially reclaimed. In the foreground, spoils were sloped to the highwall and seeded. In the background, there is an empty cavity between the highwall and spoils dump that was not backfilled or reclaimed.

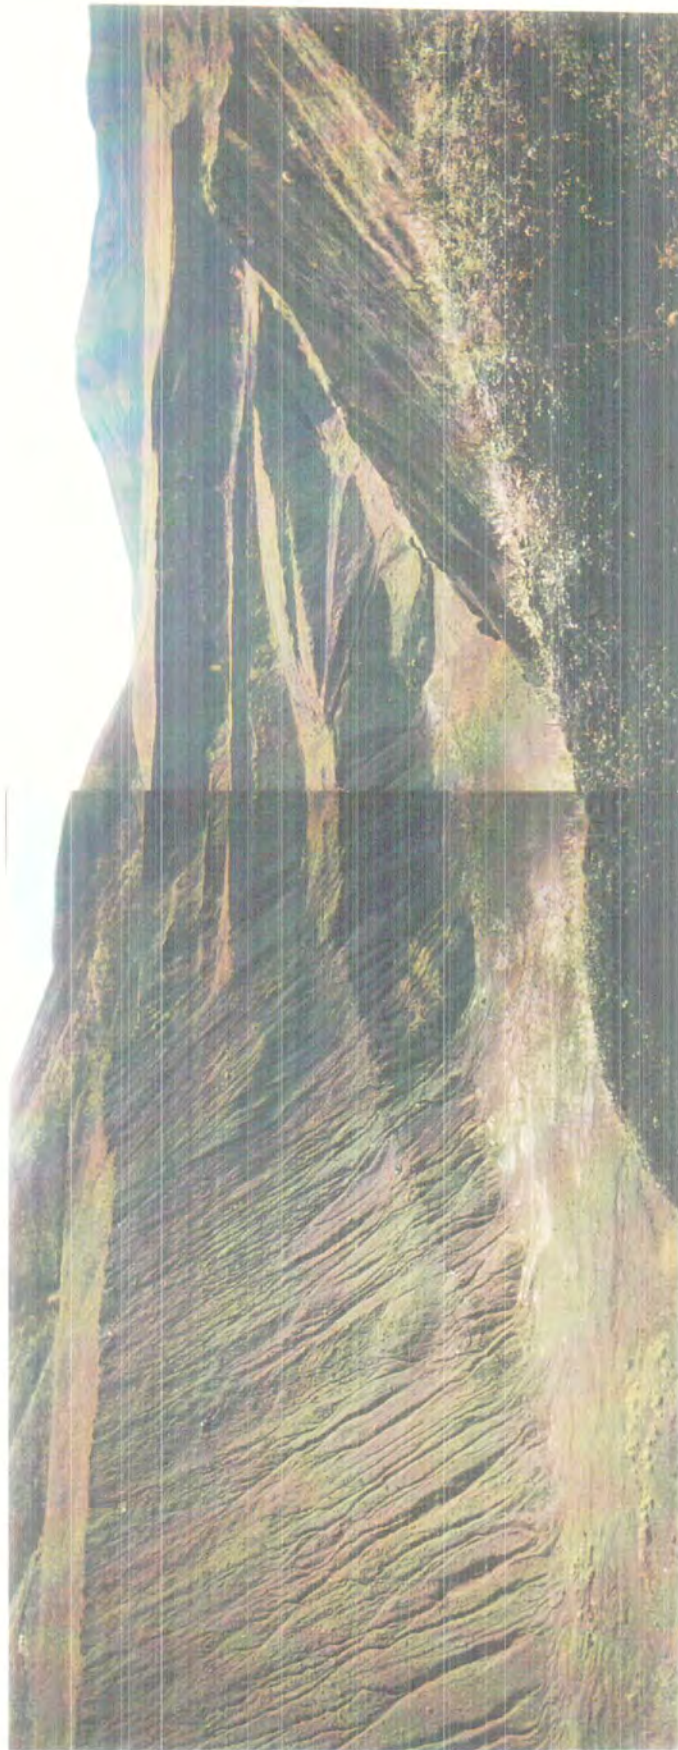
Figure 8 HH-GG Pit

The composite photo shows a post-NEPA pit that has not been efficiently remediated. Overburden was dumped over east and north highwalls (left) instead of being efficiently redistributed.

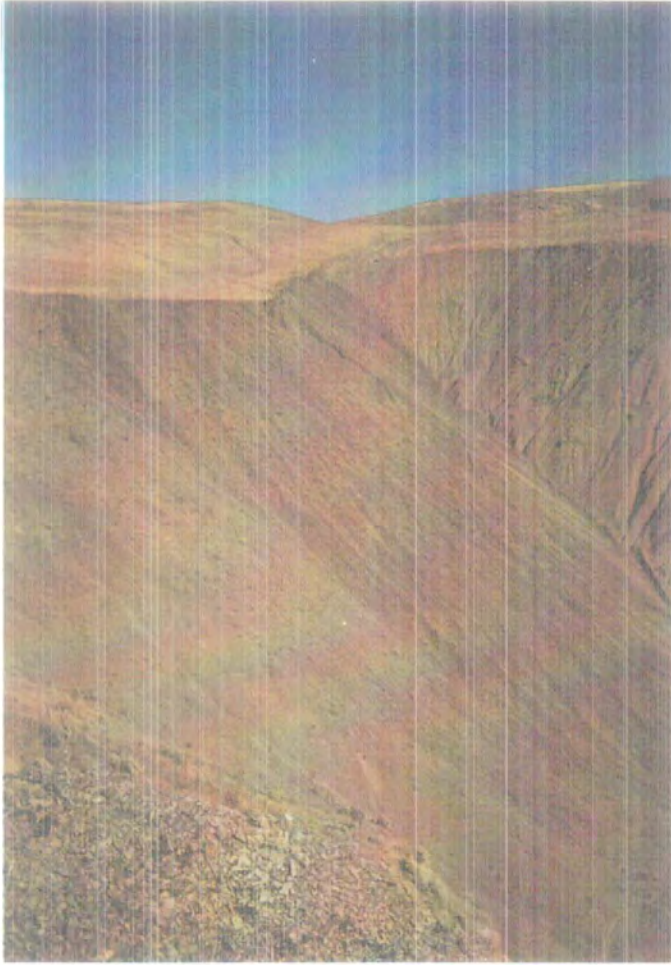
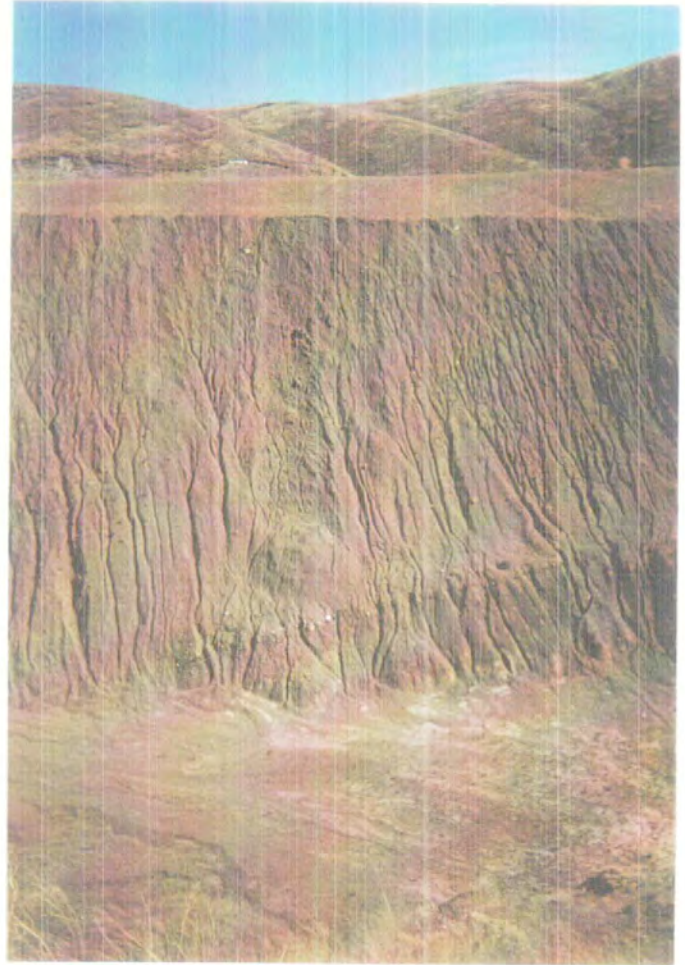
Figures 9 and 10 Close-ups of dump faces in HH-GG Pit.

Within this pit, only the spoils dump has been revegetated. The pit was used for waste disposition but the spoils material was not put to good use.

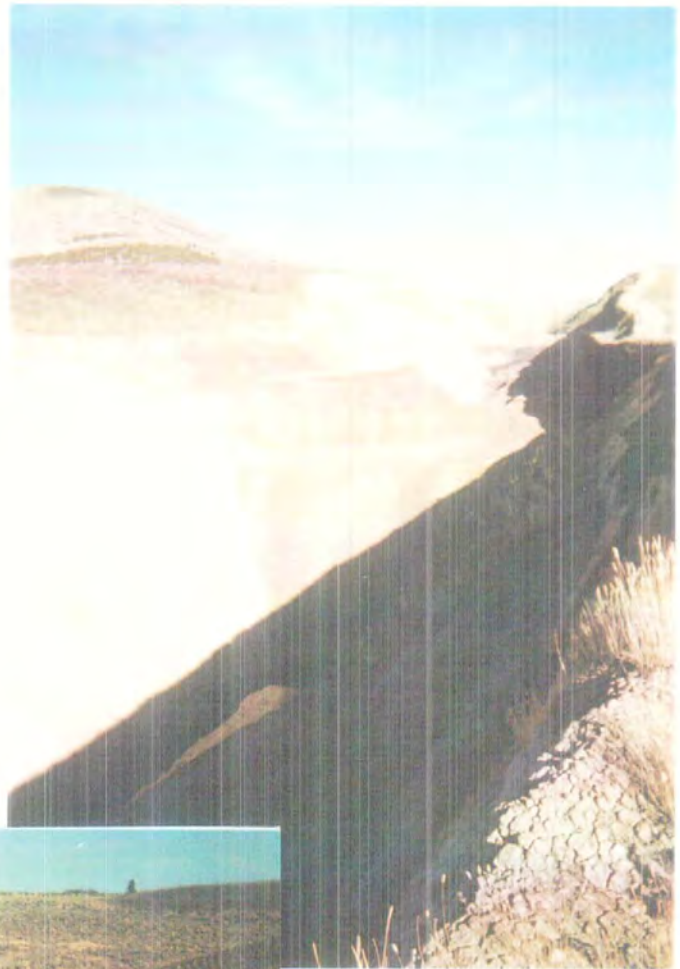
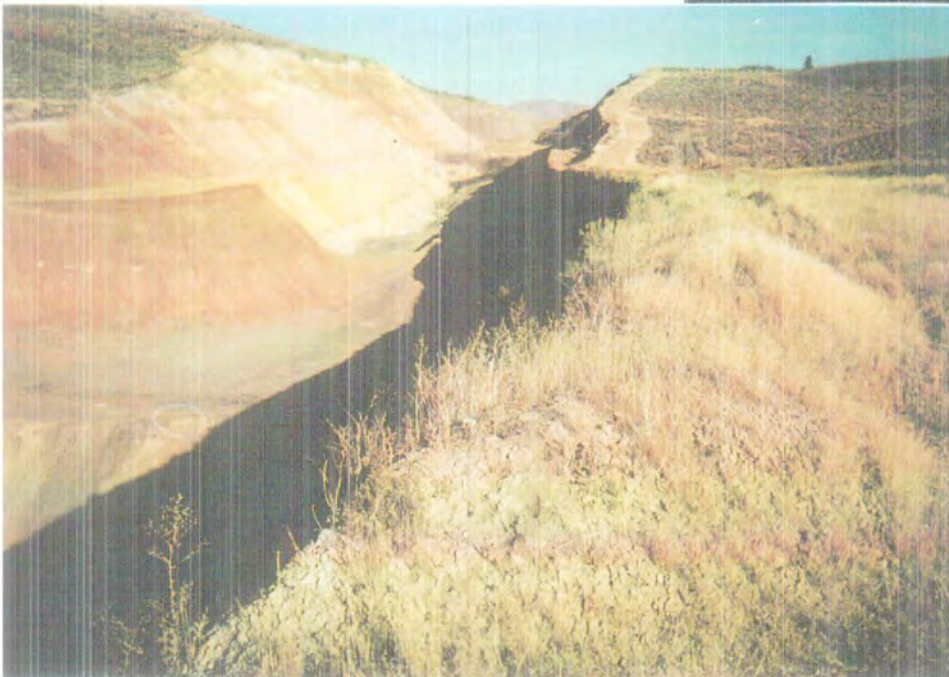
Figure 13 JC Pit

This site has been partially backfilled with spoils from JD Pit. It is separated from JD Pit (which is not backfilled) by the steep berm in the lower left corner of photo.

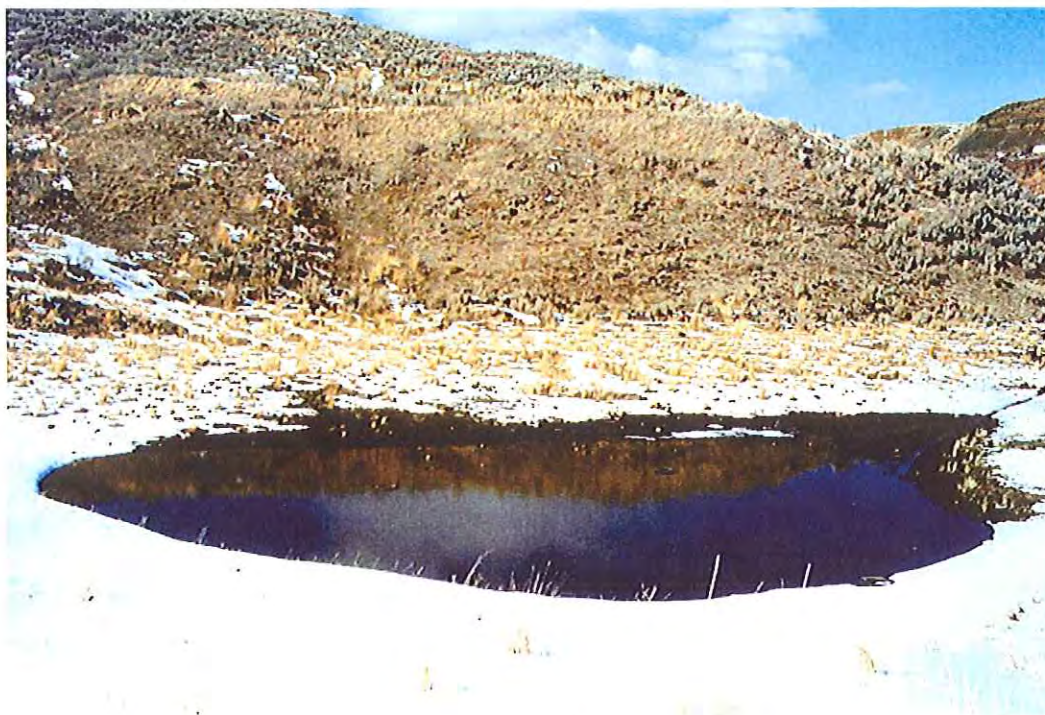
Photograph No. 3.2-2
Small trapped pond at O Area. No outlet. Water area for cows.
3/2/00

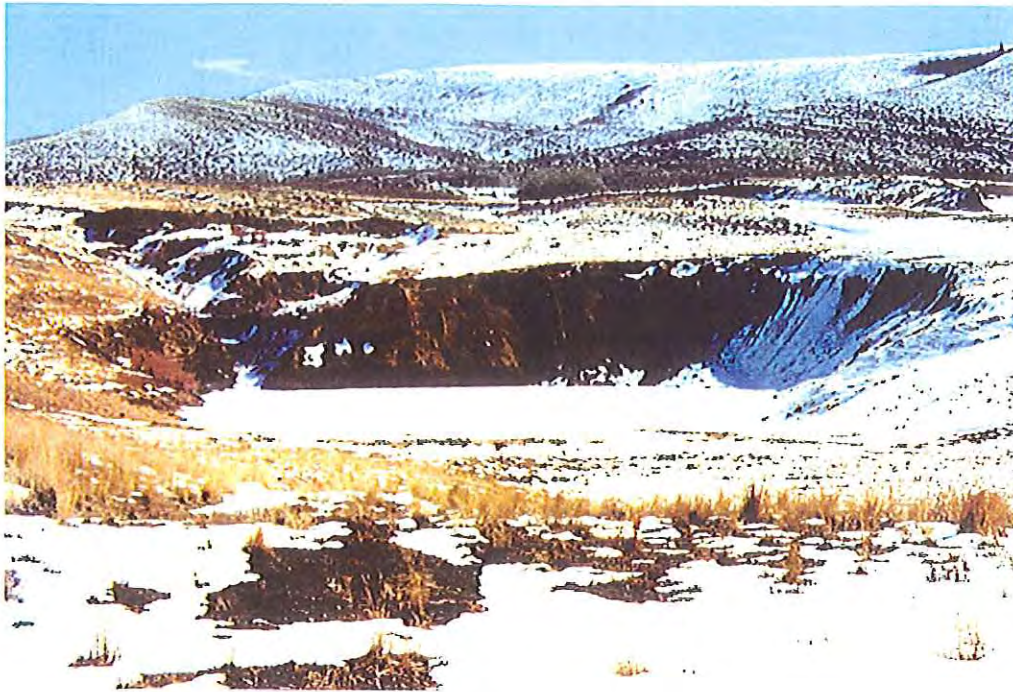
Photograph No. 3.3-1
A 12 Pit
3/2/00

The A-12 Pit area is shown on Photo 3.3-1 and Drawing A 12. This pit is close to the Mine Camp facilities and has a very large pond in the eastern area of the pit. The water level of the pond varies seasonally. The water sources for this pond are from spring fed ponds to the east of A-12 and

water seeps along the east and south highwalls. The flow into the A-12 pond has caused erosion features in the east and north highwalls.

The large area of the A-12 Pond and the large volume of required backfill may be offset by diverting the inflowing water, dressing up the highwalls and fencing the perimeter of the high-water level. If the major source of water for the A-12 pond is diverted, the level of the pond should decrease (the remaining water source would be seeps). It is possible that the pond may dry up during part of the year and that fencing could be used to keep large grazing wildlife and livestock away from remaining water. A complication of this approach is that evaporation of pond water may take a long period of time. Therefore, the fencing would need to extend beyond the current high-water line in order to keep the stock away until the water level drops.

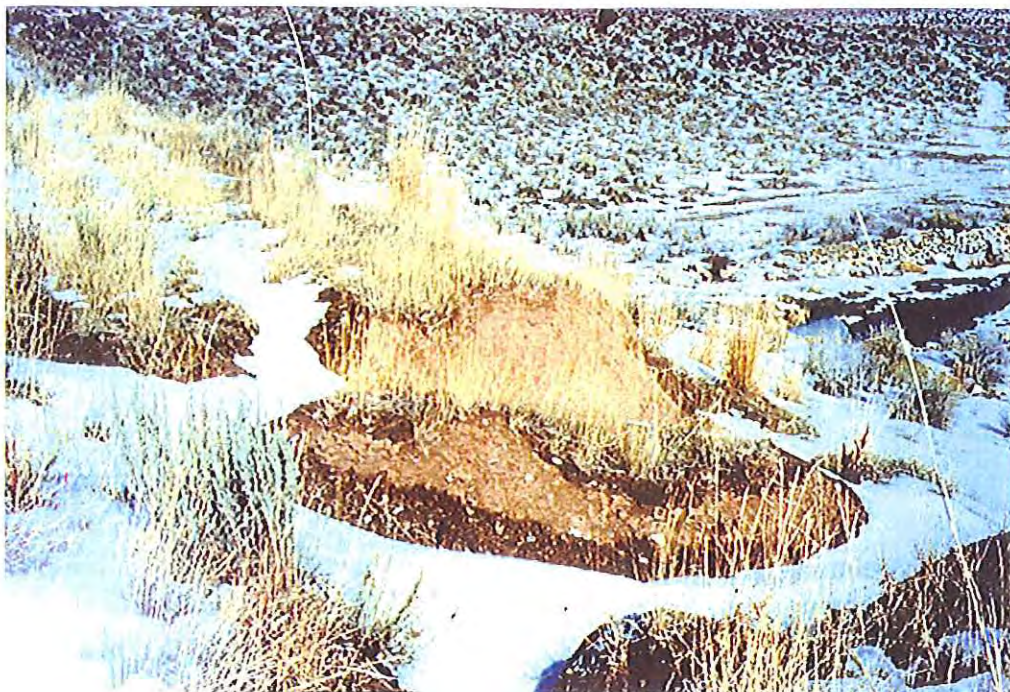
Photograph No. 3.4-1
NE Side of J culverts fix or pull out for fill
3/2/00

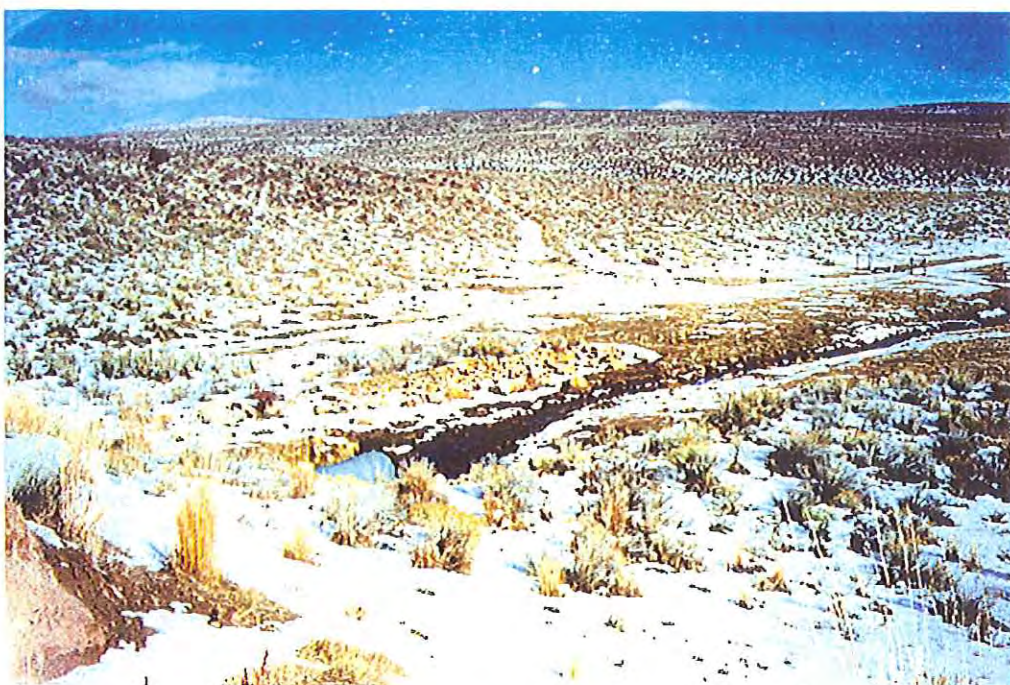
Photograph No. 3.4-2
NE side of J culverts fix or use for fill
3/2/00

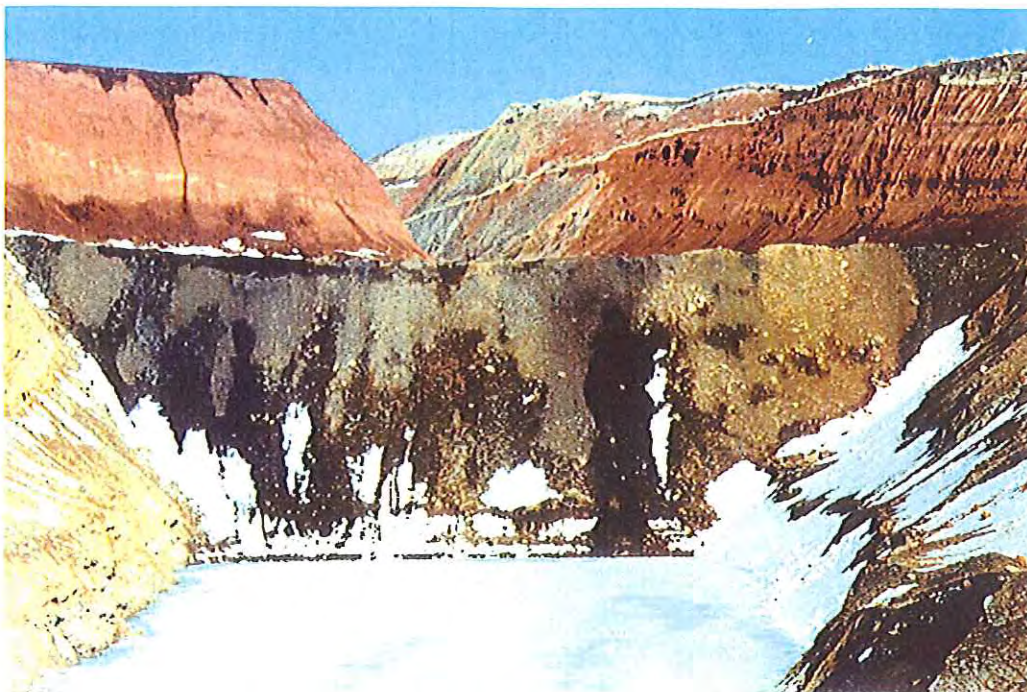
Photograph No. 3.4-5
JF Pit Waste Dump use to fill lower part of pond
3/2/00

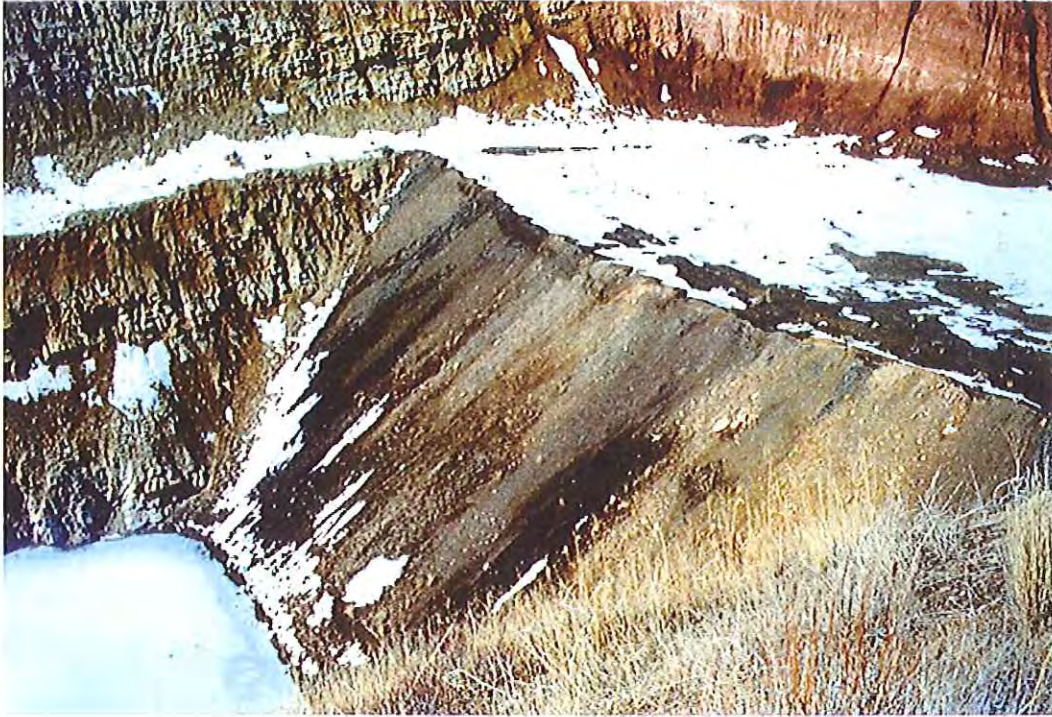
Photograph No. 3.4-7
JF fill area-push to bottom
3/2/00

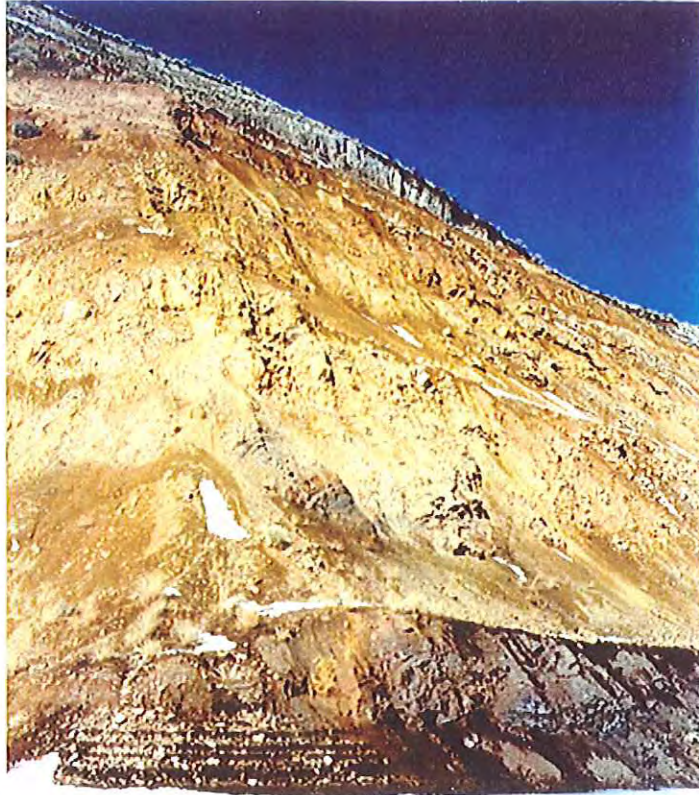
Photograph No. 3.4-11
JF Pond fault area-raises seam material 25' above other areas
3/2/00
